INDOOR AIR QUALITY ASSESSMENT

**Massachusetts Department of Mental Health
Site Office Region II
40 Institute Road
Grafton, Massachusetts**

Prepared by:
Massachusetts Department of Public Health
Bureau of Environmental Health Assessment
January, 2001

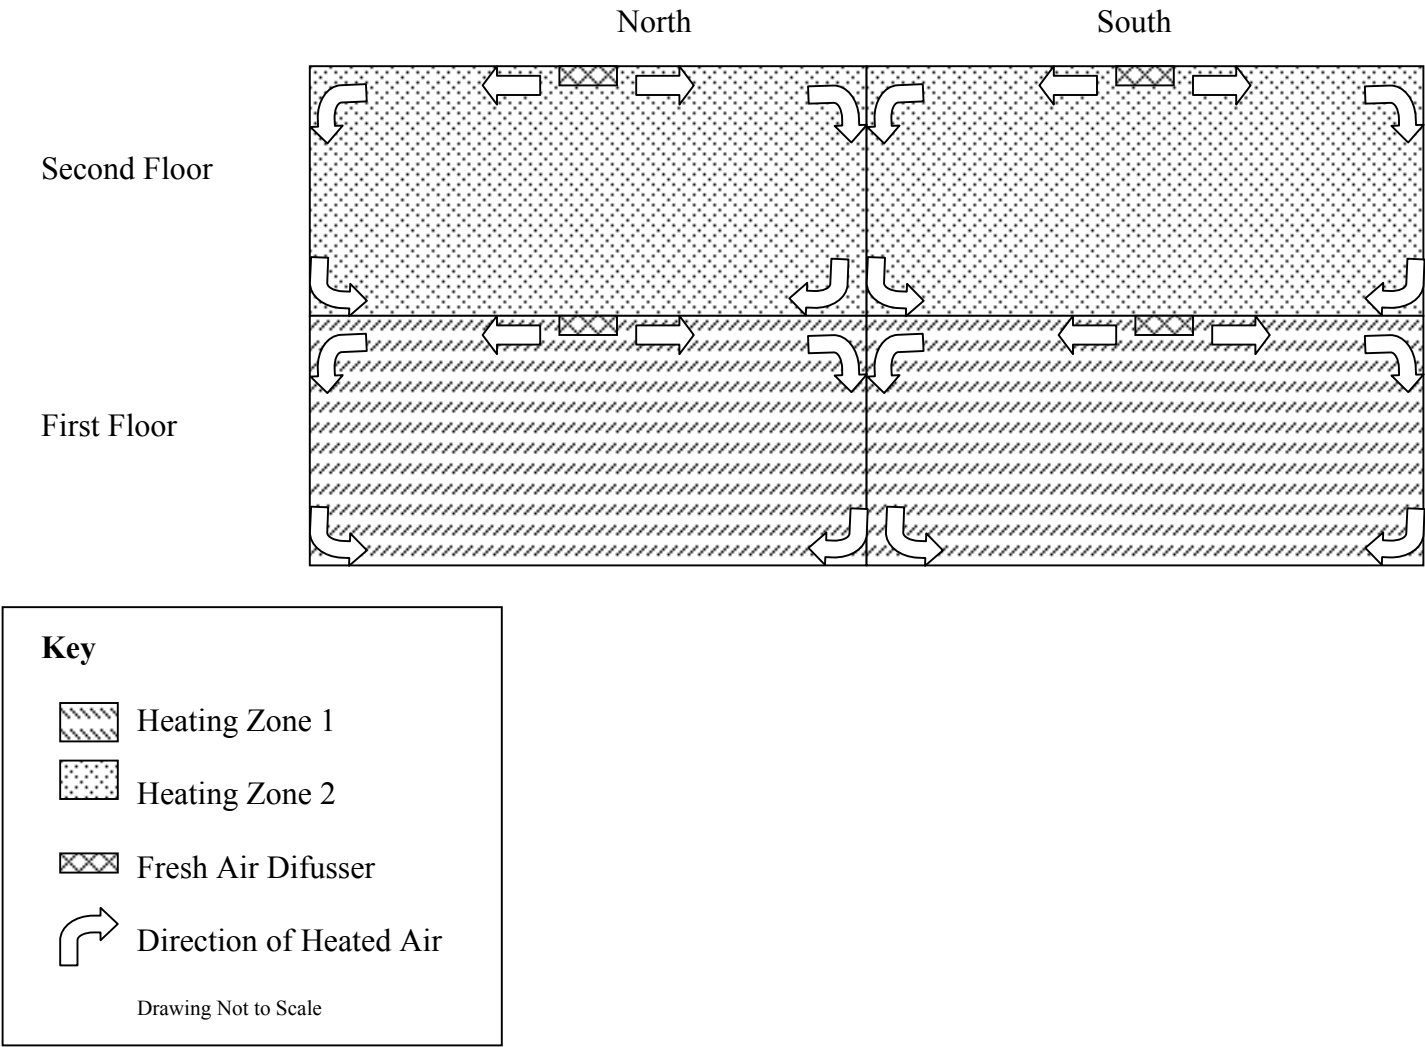
Figure 1

According to building occupants, temperature control between the first and second floor is difficult. If temperature is comfortable for first floor occupants, second floor occupants report cold temperatures. If heat is raised to make the second floor occupants comfortable, the first floor occupants report hot temperatures. The configuration of the mechanical and natural ventilation systems can contribute to this lack of temperature control. The usual design for ventilation systems evaluated by BEHA staff is to provide ventilation on a horizontal plane, with each AHU distributing conditioned air to a single floor. (see Figure 1). Instead, each AHU in this building services a vertical cross-section of the building (see Figure 2), with the original natural ventilation system continuing to operate. With this design, the increase of temperature to provide heat to the second floor would result in the natural ventilation system increasing temperature into the air mixing room heating elements. With increased heat from the heating elements, warm reheated air is introduced into the first floor. Without the AHUs operating to provide fresh air to the building to temper air, increased complaints of excessive heat would be expected on the first floor.

Usual Configuration of Heating Zones
